Reference: Tree Inventory Report

Date: January 22, 2024

Site Address: 6539 44th Ave SW, Seattle 98136

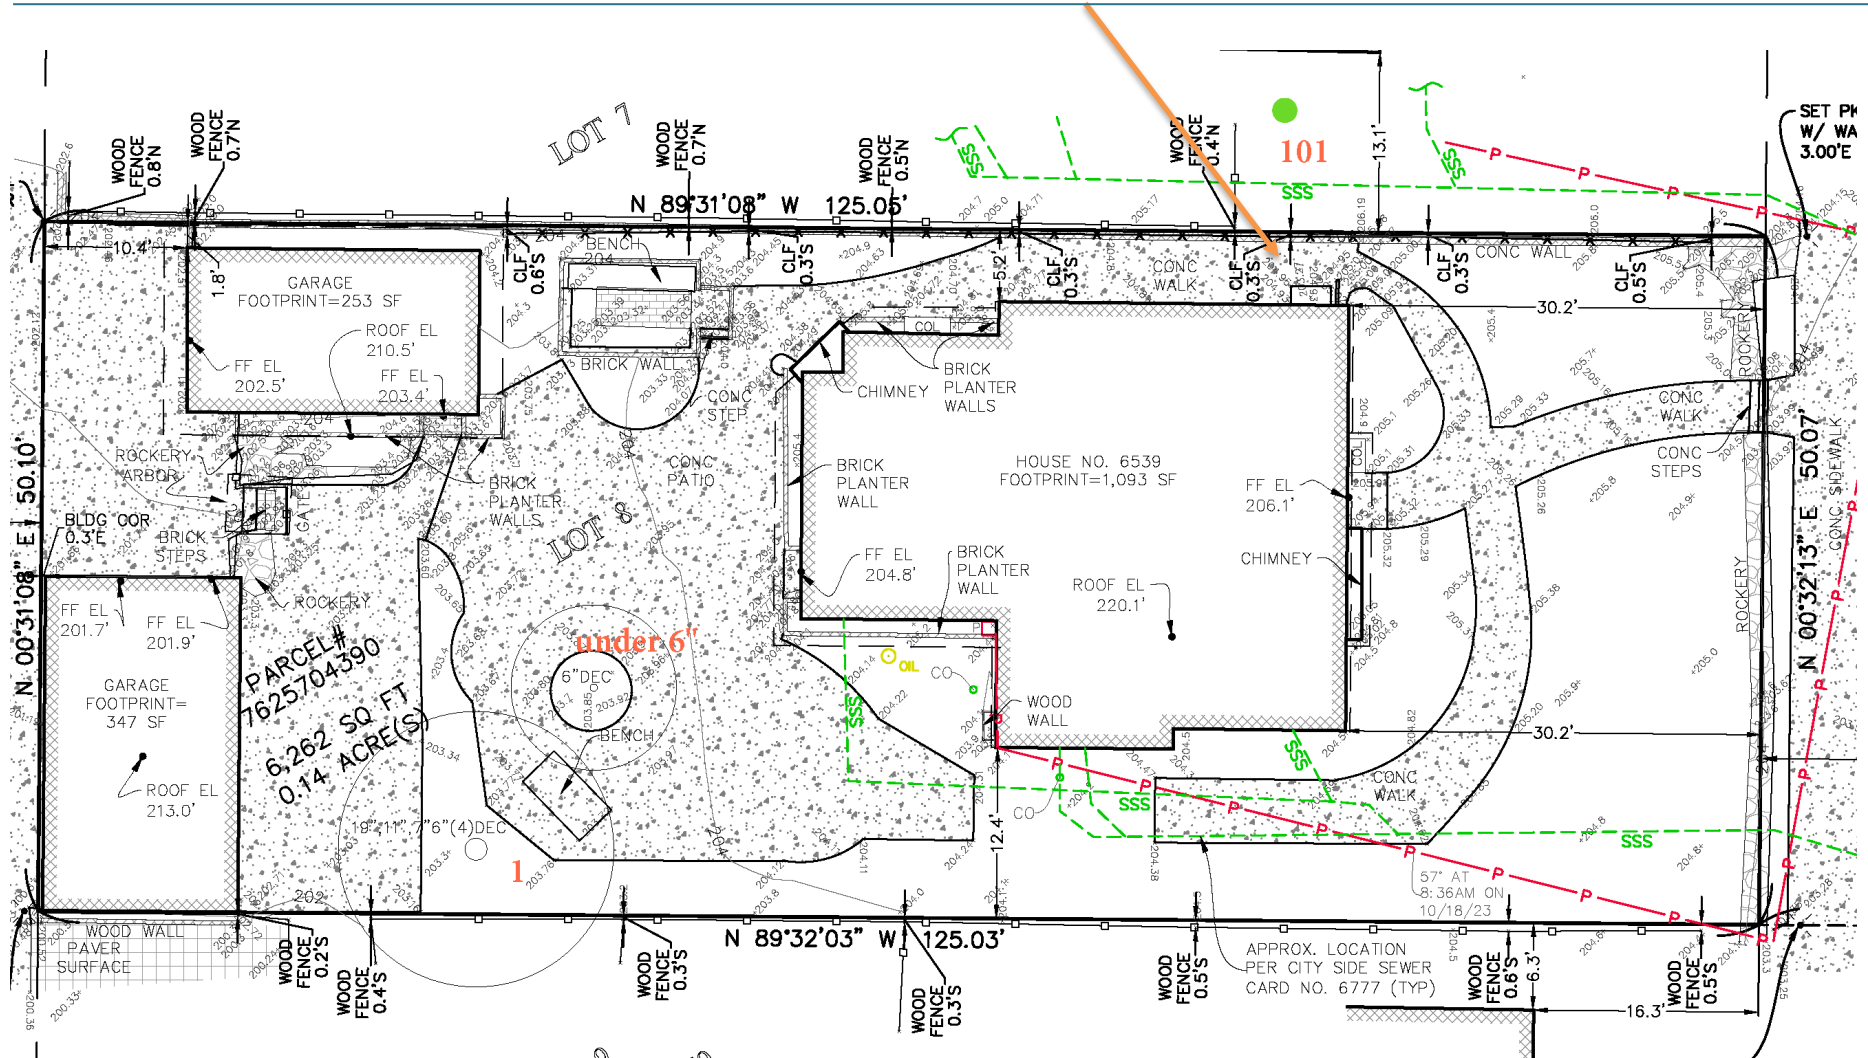
Attachment 4: Annotated Survey

Possible Tree Protection Area (TPA) – work zone may be required

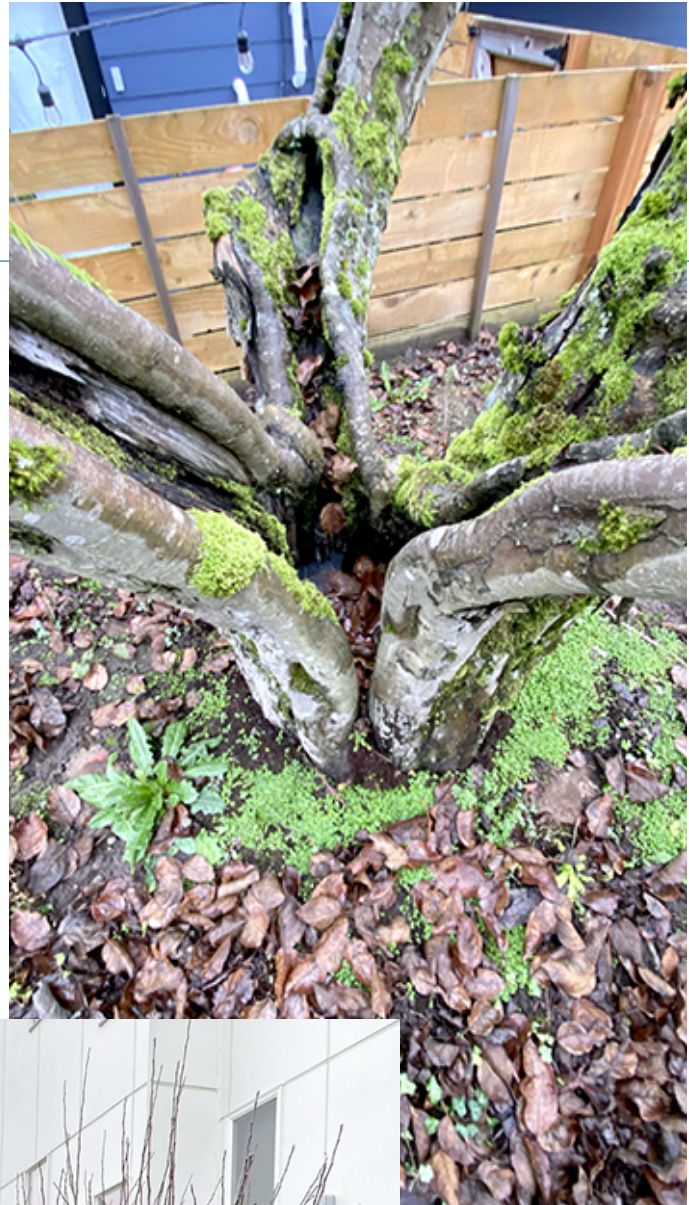
Tree #	Species	DBH inches	Dripline radius in ft	Category	Health	Structure	Notes
1	<i>Malus sp.</i> Orchard apple	22	10	Tier 2	2	3	Multiple leaders. Significant decay at trunk base and throughout main stems and branches. Over-pruned with numerous watersprouts and poor branch attachments.
101	<i>Prunus cerasifera</i> 'Thundercloud' <i>Thundercloud plum</i>	10	9	Tier 4	2	2	Estimated measurements. Located on north parcel. Branches overhang 4 feet, toward existing home. Several suckers at base of tree. Asymmetrical canopy.

Right: The 22-inch Tier 2 Apple tree located behind the existing home. Significant decay in trunk base and throughout main stems.

While the apple tree meets the threshold of a protected Tier 2 tree under SMC 25.11 and Director's Rule 7-2023, it is not a viable tree for retention due to significant decay and extreme stress from over-pruning. I recommend the tree be removed and a new tree included in the development proposal to meet the requirements of tree replacement. I did not review a site plan or tree replacement as part of my assignment.

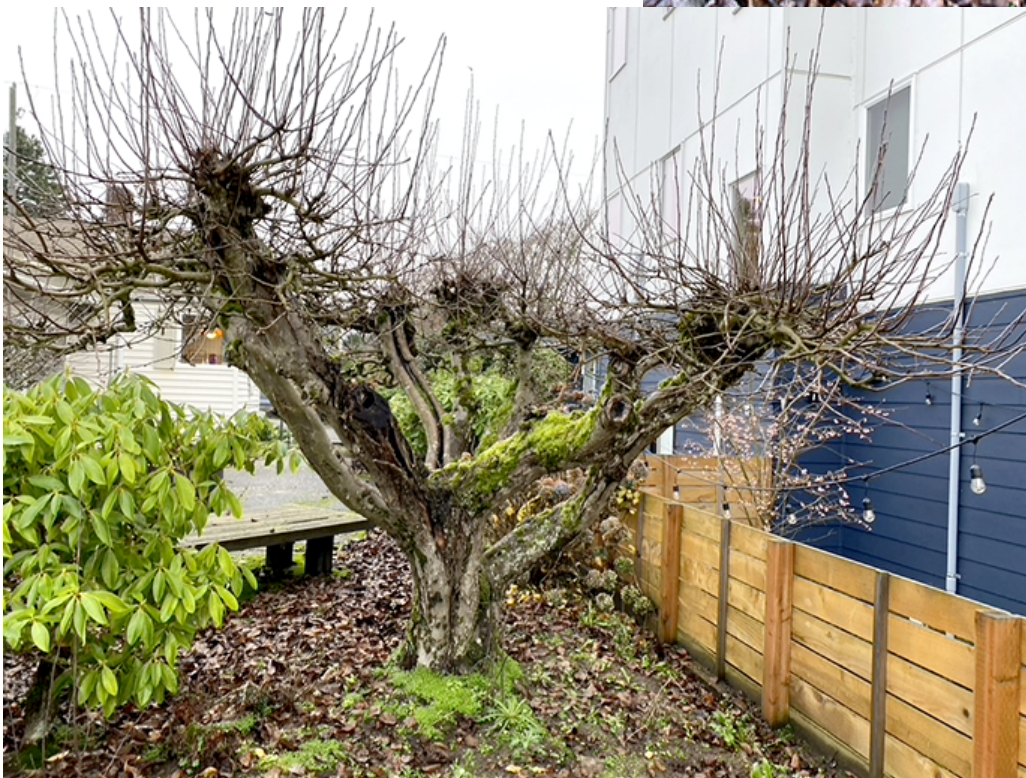
Below: Looking east toward existing home. Watersprouts from aggressive pruning are evident, along with decay in trunk base and main stems.

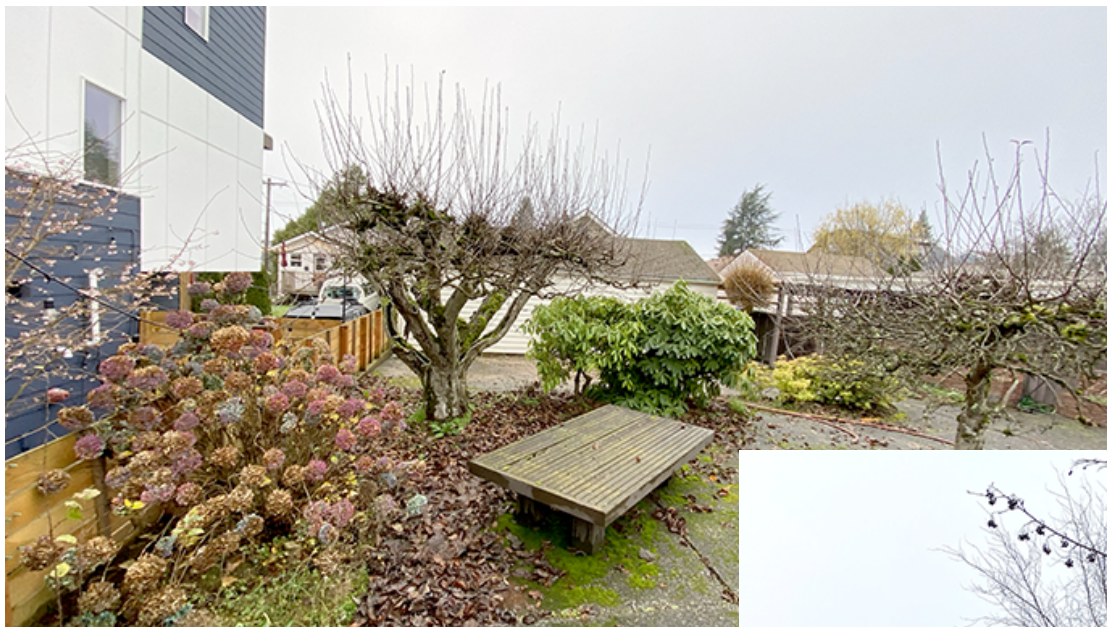
Above: The 22-inch Tier 2 Apple tree located behind the existing home, and close to the south property line. The small, unregulated apple tree can be seen on the right. It measures 5.5 inches, below branching.

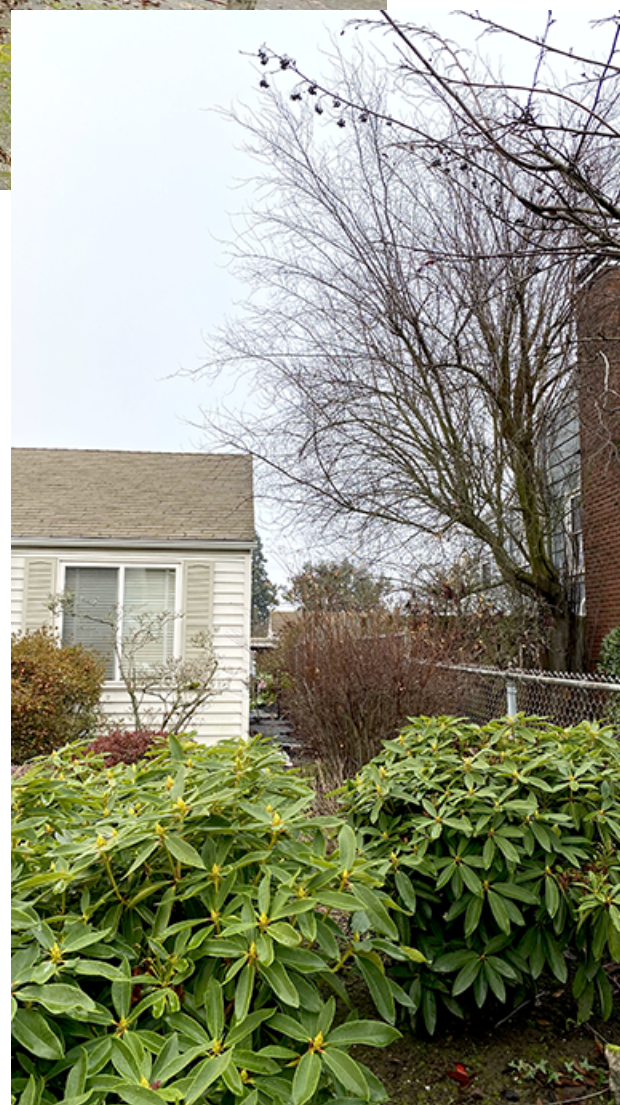
Right: Looking west, offsite Tree #101 with branches overhanging the property line, and existing chainlink fence.
